UNITED STATES ENVIRONMENTAL PROTECTION AGENCY

SUBJECT: ACTION MEMORANDUM - \$2 Million Exemption Request for an  
Emergency Removal Action at the Harrison Sheet Steel  
Site, Chicago, Cook County, Illinois  
(Site ID# OP)

**ATTACHMENT 3  
HARRISON SHEET STEEL SITE  
PHOTOGRAPHS**

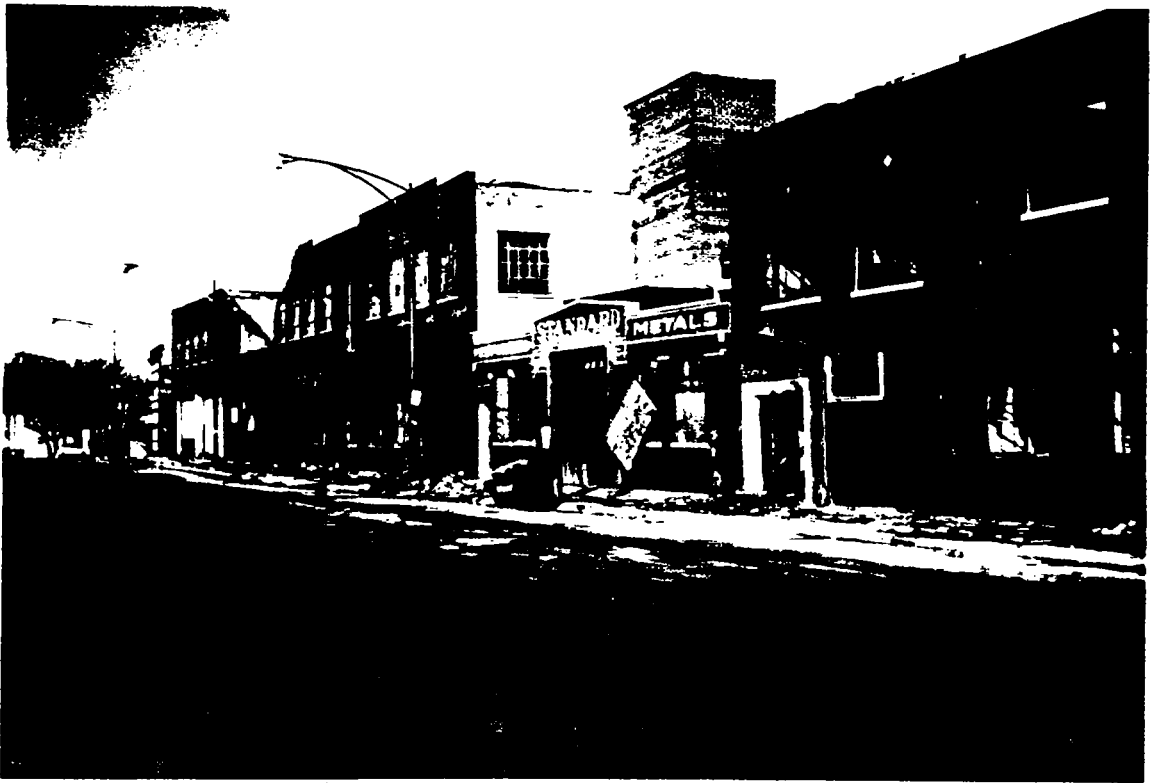
Photo #2

Direction: NW Date: 2/17/95 Photographer: Pete Guria  
 Description: Front of Harrison Sheet Steel Bldg. Note condition and fire damage. Yellow Structure to the left is a residential home.

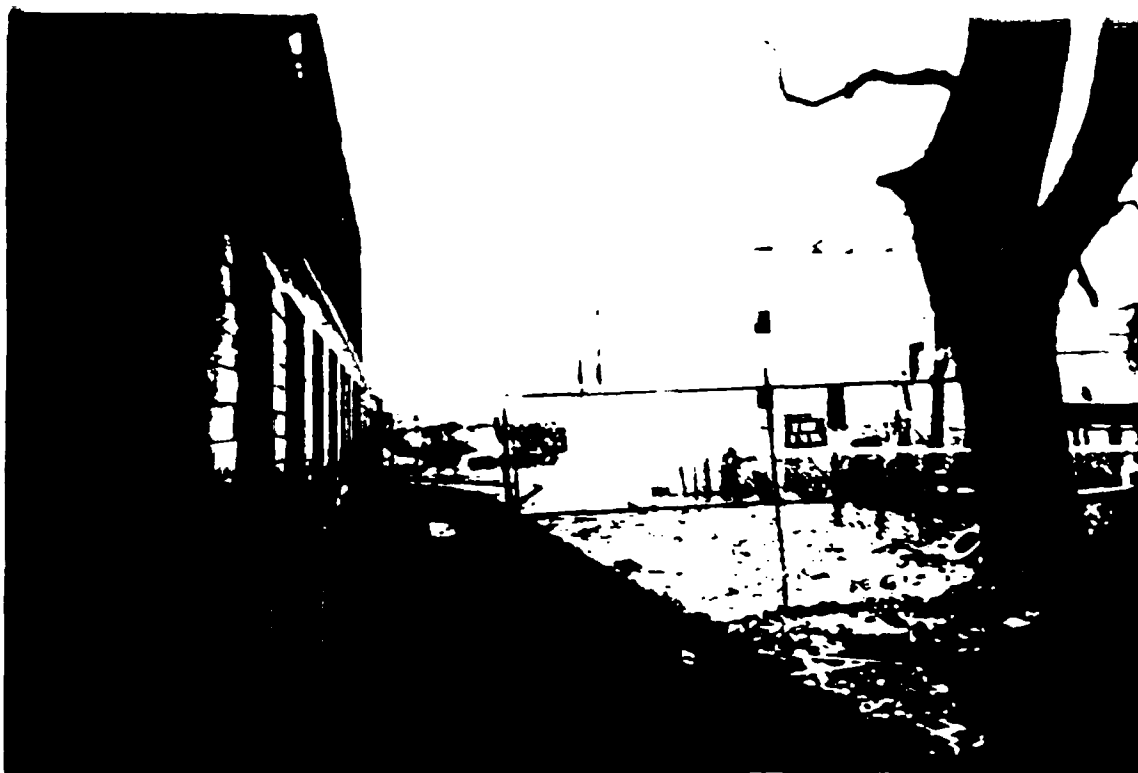
**Photo #3**

Description: View of west end of Bldg. Note condition and residential home to the right.
